MPET repair, modification and upgrade 2010

The baking of the MPET in the beginning of 2010 had lead to several shorts in the tube of the MPET. This document describes the repair and the modifications of the MPET. At the same time we upgraded the detection and vacuum system. These upgrades are also documented here.

stephan ettenauer
(January, 2011)

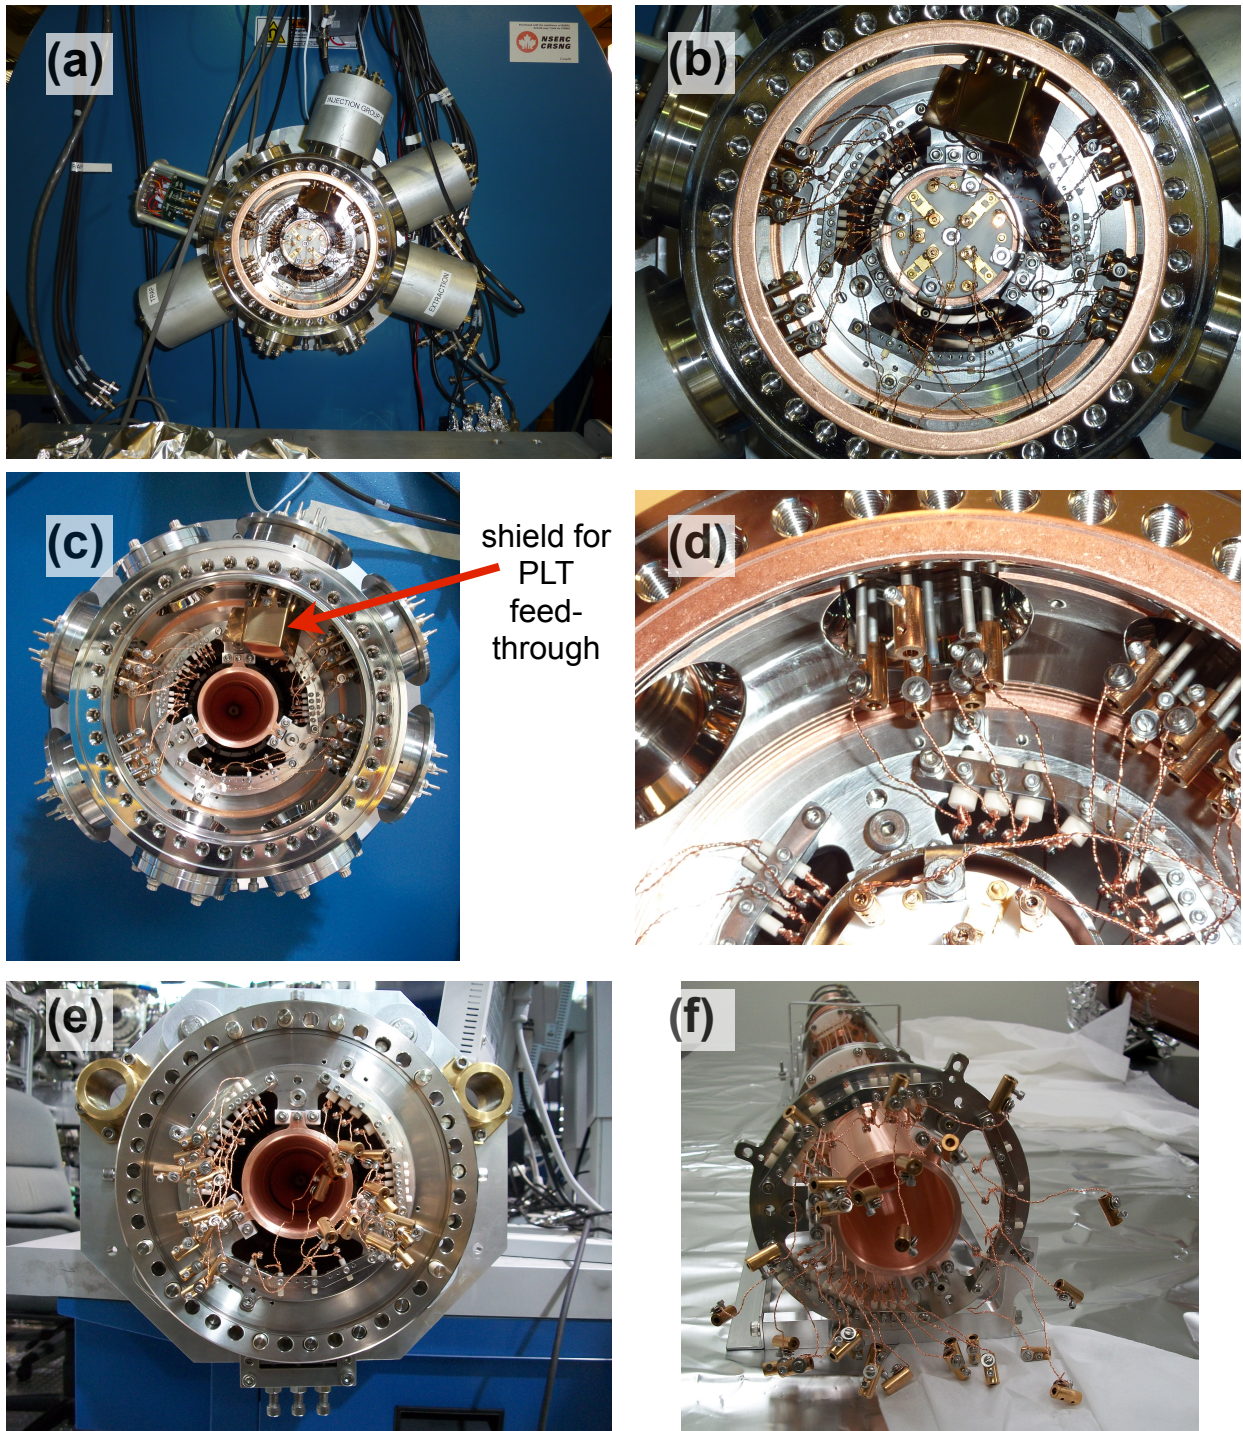
Figure 1

- (a) Feed-through section with MCP. The feed-through section is attached to the titanium tube which is in the magnet bore.
- (b) Magnification of (a)
- (c) MCP removed
- (d) Magnification of wires running from the feed-throughs to the wire terminals.
- (e) Feed-through section removed and tube pulled out of magnet bore
- (f) Trap structure pulled out of titanium tube.

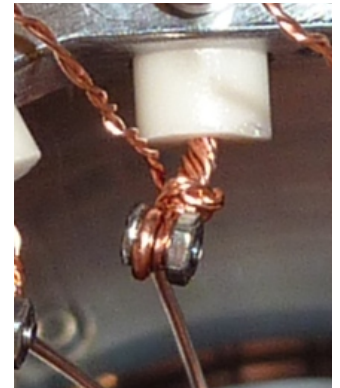
Figure 2

The (twisted) wires coming from the feed-throughs were twisted around the wire terminals in order to connect to the wires which lead to the actual electrodes (see Figure 2). This method requires substantial amount of work to remove and reconnect the wires. Due to modification (2), we had to do this and decided to change the wire terminals to faster reconnect the wires and allow easier maintenance in the future.

Furthermore, during the baking one of these old connections actually broke.

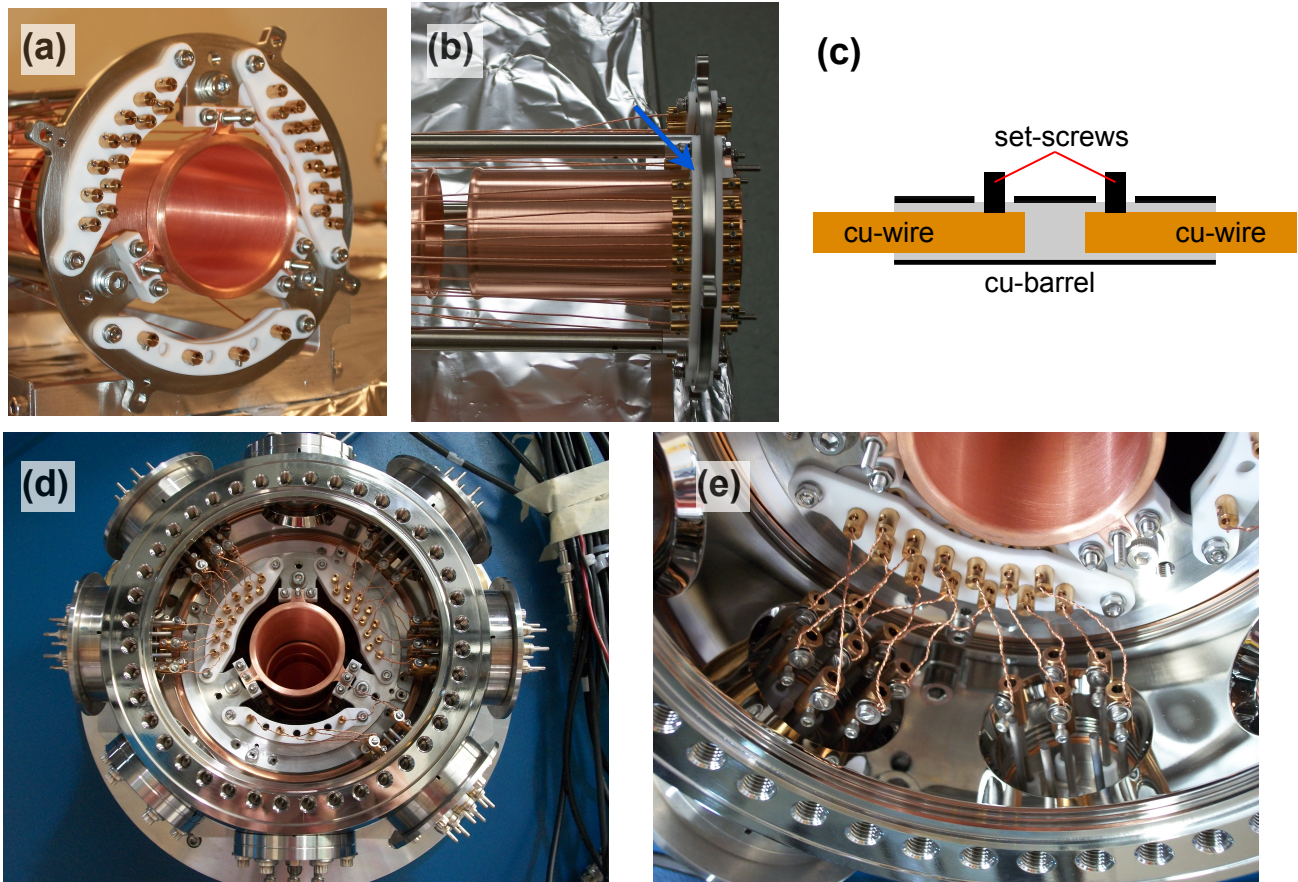
Figure 3

Because of (1) we needed to place a ring between the tube and the last flange of the support structure: The blue arrow in Figure 3(b) denotes one of totally three new macor pieces (=parts of the new wire terminals) which do not fit into the titanium tube. The ring has a wider inner diameter than the tube to fit these pieces.

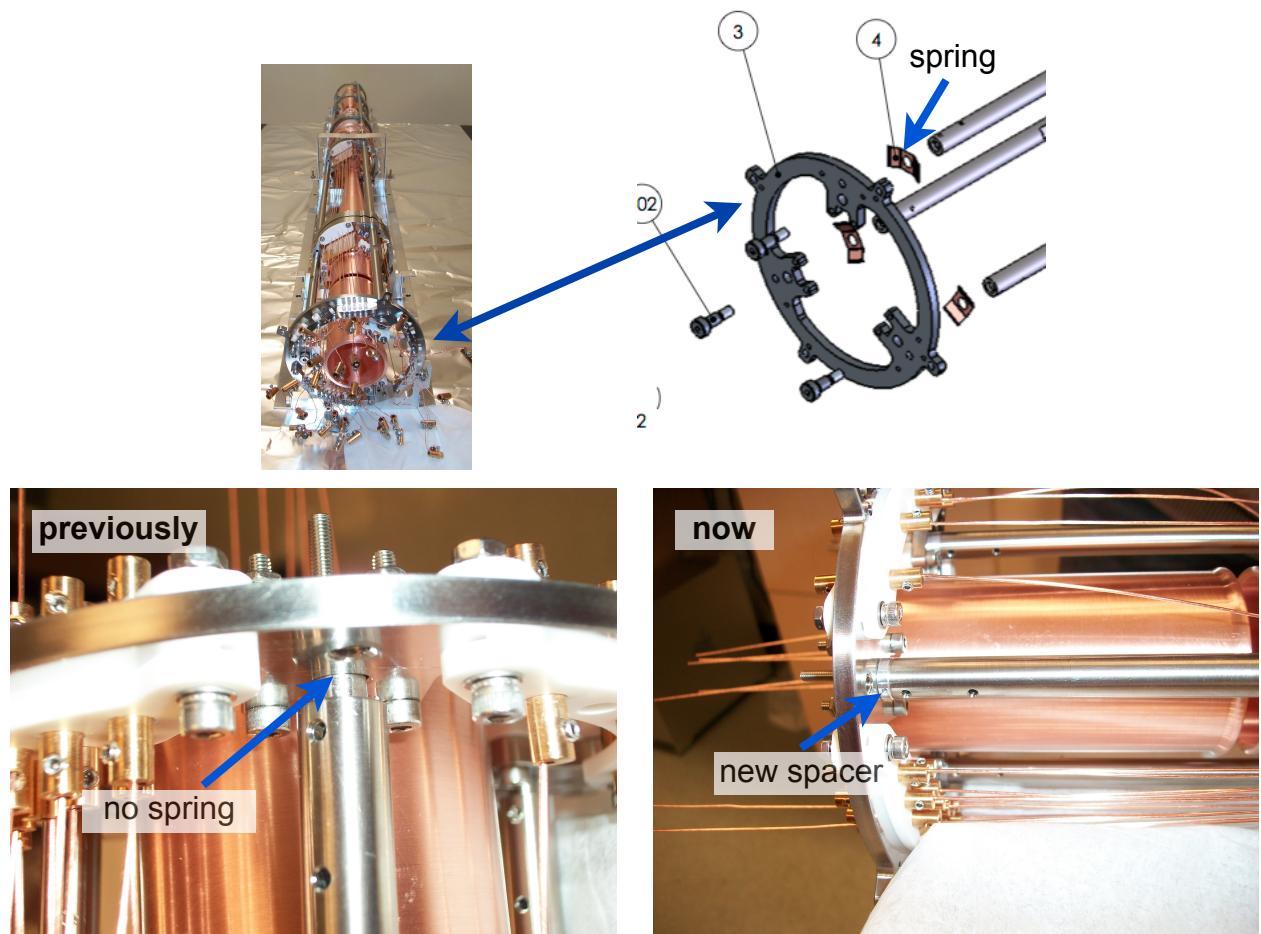
Figure 4

According to IEX0514_revA there should have been springs (IEX0474_revA) between the flange with the wiring terminals and the frame rods (see Figure 4). These would allow the expansion of the support structure (e.g. during baking). However, this setup was disadvantageous in two ways:

First, the support structure was forced to expand in the opposite direction of the wires: the wires were fixed to wire terminals which themselves could not move (because the flange is bolted onto the tube). At the same time the wires are also fixed in respect to the support structure, which expands towards the feed-through section. This probably caused a few of the shorts after the baking.

Secondly, the springs were actually missing in the assembly (see Figure 4), which means the trap was not constraint in the axial direction!

Instead of the springs, we now placed spacers between the flange and the rods (see again Figure 4). The length of the spacers in 4 are chosen in such a way that all electrodes (except XZT3, see (4)) are at the same position in the magnet as the initial drawings (without the ring in modification (2) but with the springs) had indicated.

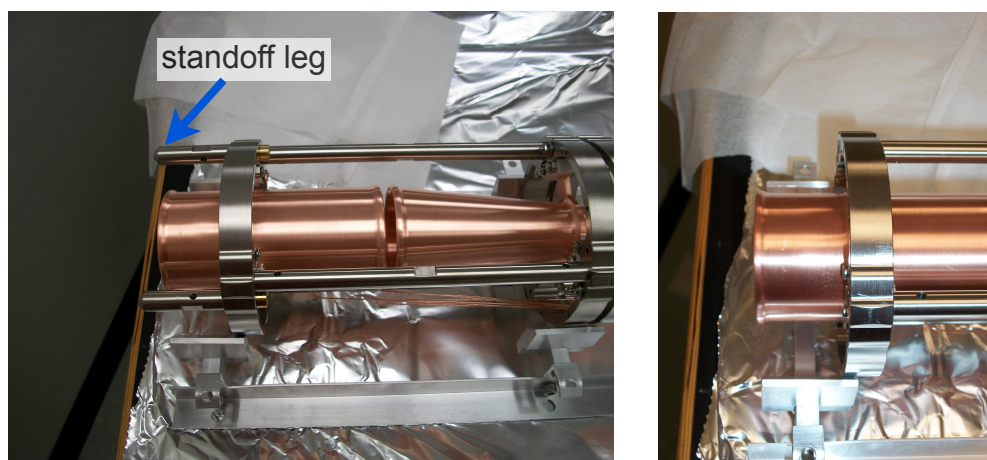
Figure 5

The standoff legs in the initial design (Figure 5) were probably added to prevent the first electrode touching the end of the tube. To allow for expansion the springs mentioned in (3) had been added. Since we have now replaced the springs by spacers, we also removed the standoff legs (Figure 5 on the left). According to the drawings there should be enough space between the first electrode and the end of the titanium tube to allow expansion of the support structure in upstream direction.

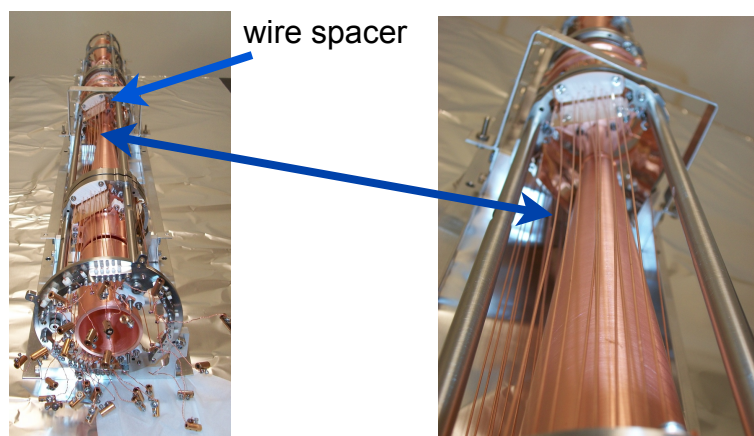
Figure 6

The wires running inside the tube were previously held apart by wire spacers (see IEX0505_revA). This has led to (often only temporary) shorts between electrodes as the wires could touch each other in certain sections (see Figure 6).
